Derwent Angling Association (Consett) habitat works proposal

Introduction

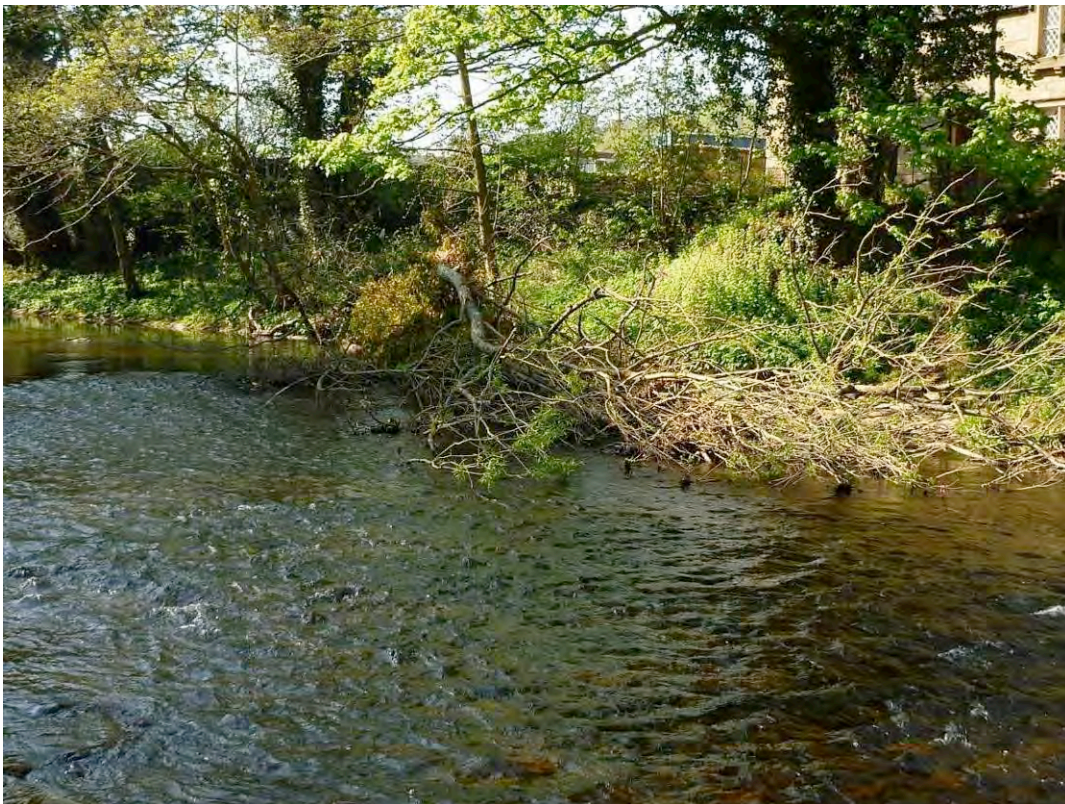
Figure 1: Naturally-occurring marginal debris - a credit to the club policy of retaining this valuable habitat resource in the river channel. In the example pictured, the survival of juvenile fish will be greatly enhanced.

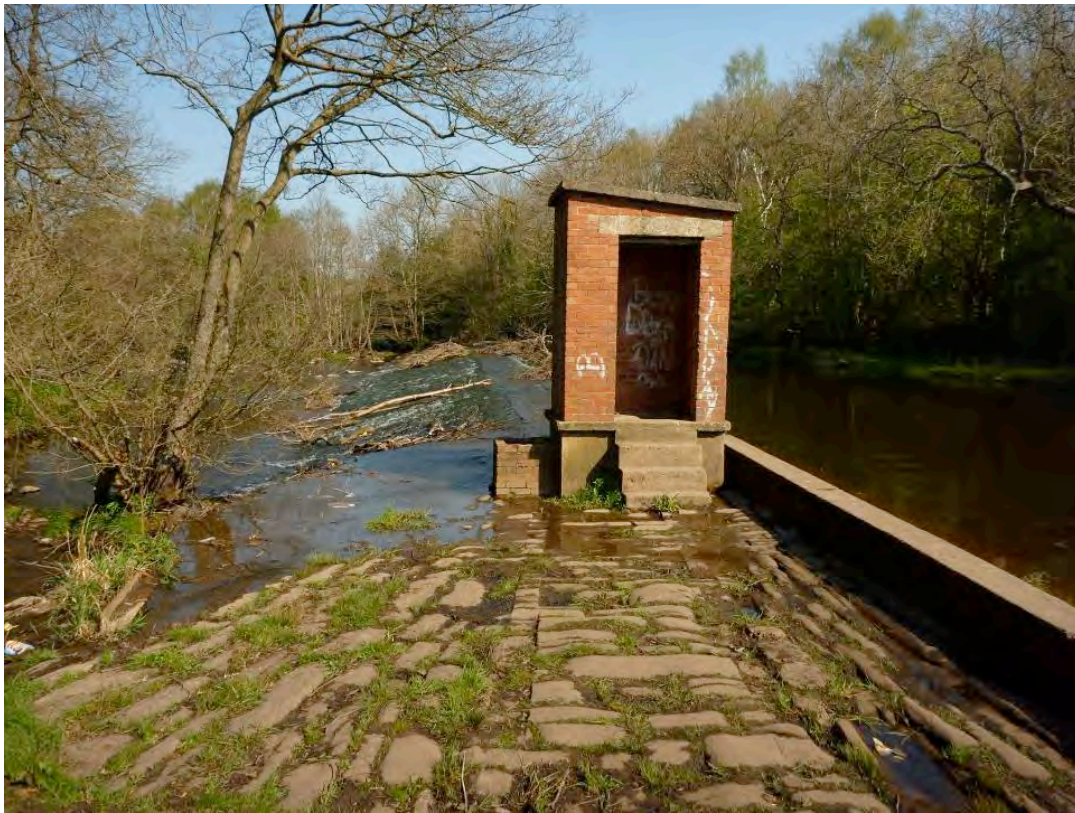
Figure 3: Weir at NZ 08507 51596

It is clear from discussion with Alan Farbridge that this structure (Fig. 3) is an important amenity to the club during introductory days for young anglers and events for anglers with restricted mobility. It provides a ponded area that retains stock fish and has good bankside access.

Therefore, we would not seek to notch and reduce the vertical head of the structure (as would be more usually recommended). Instead, the potential for linking good quality patches of habitat should be maximised to allow resident fish to exploit their preferred resources. It should be possible to fit a simple “balk” easement such as the example from the Wye and Usk catchment illustrated here (Fig. 4) and included in the plan of works (Fig. 13). It is worth bearing in mind that, for the smaller weirs just above this section, there are likely to be many benefits from partial removal of impounding structures (cutting slots that are approximately $1/6^{\text{th}}$ of the channel width would be appropriate).

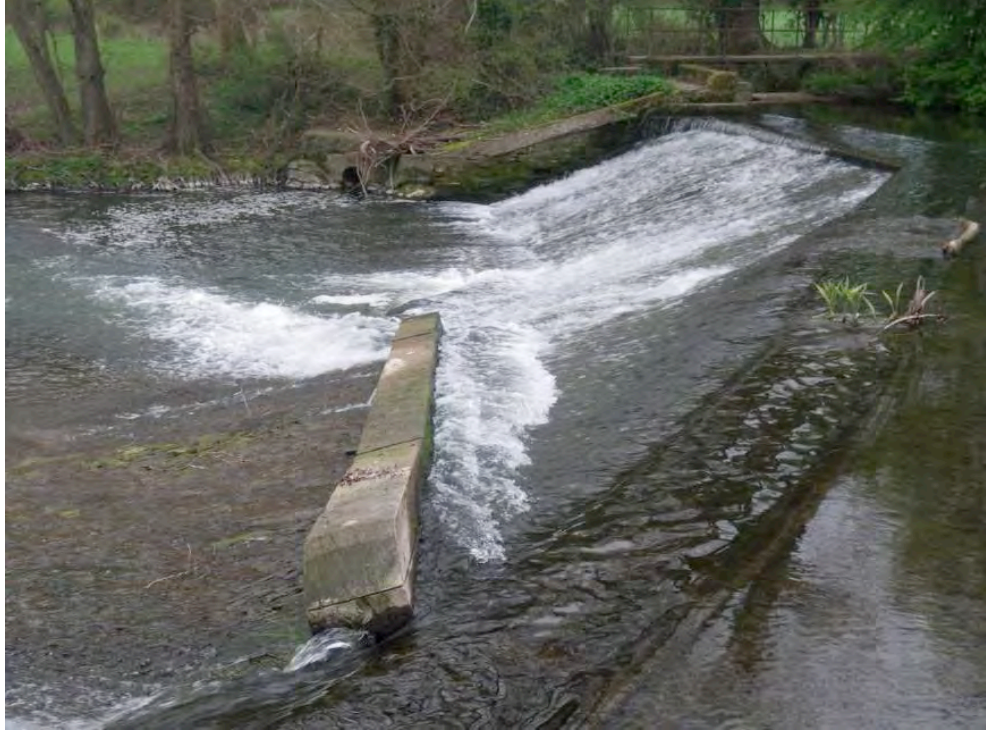
Figure 4: Baulk easement installed by the Wye and Usk Foundation. Sleepers are attached to the face of the weir by means of expansion bolts drilled into placements within the stonework (see Appendix 1 for E.A. guidance)

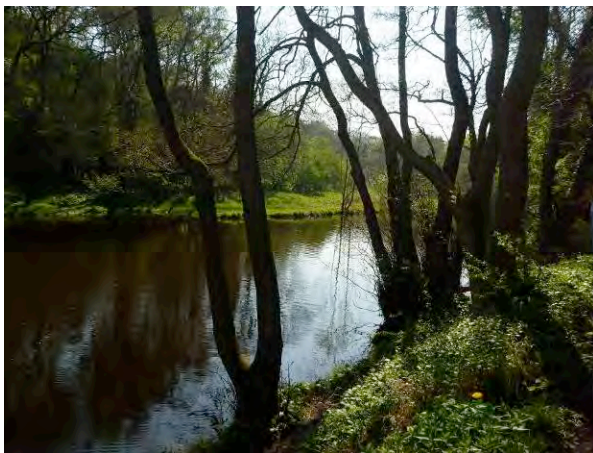
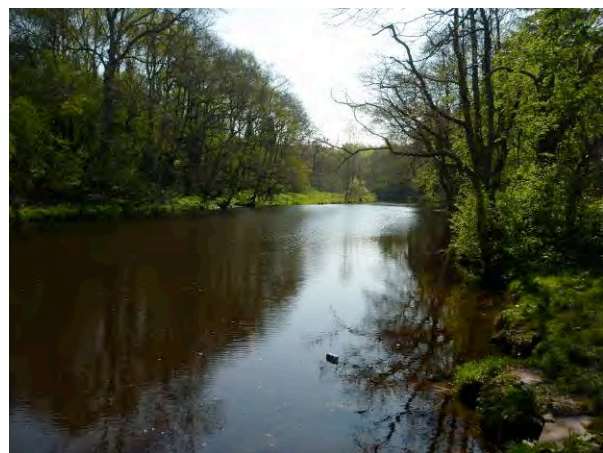
Figure 5: Uniform habitat and impounded water above the weir that would benefit from additional structure and variety

To maximize the potential of both the existing habitat and the value of the baulk easement, the impounded water upstream (Fig. 5) would benefit from installation of submerged structure (mid channel and in margins). This kind of cover is probably the best protection that fish have against predation – especially from birds. Rebar pinning of root wad material and whole trees along with “hinging” (Fig. 6) of bank-side trees or attaching trees to their stumps with 12-mm diameter braided steel cable (Fig. 7) are appropriate here; as detailed in work plans (Figs. 13 and 14). Test attempts to drive 2-m long rebar pins (19-mm diameter) into the stream bed would be required to confirm viability of pinning in advance of works

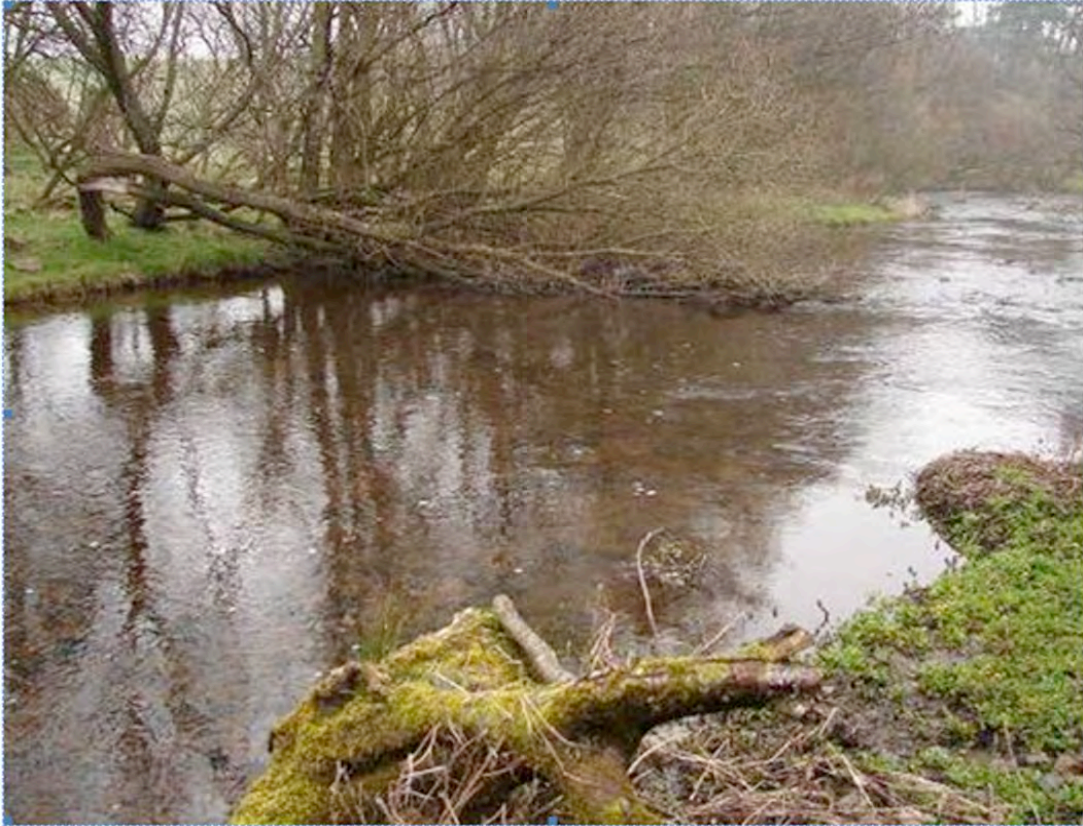
Figure 6: Hinged tree on the River Derwent

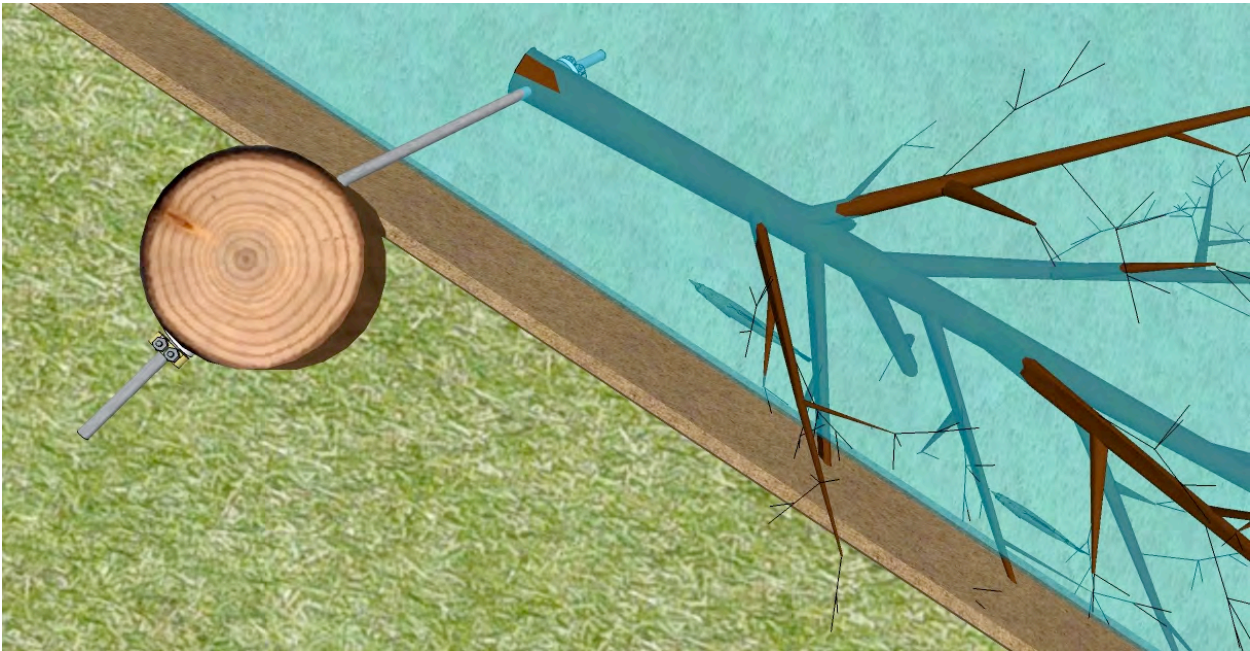
Figure 7: Plan view of tree "kicker" secured to its stump via 12-mm steel cable and cable crimps

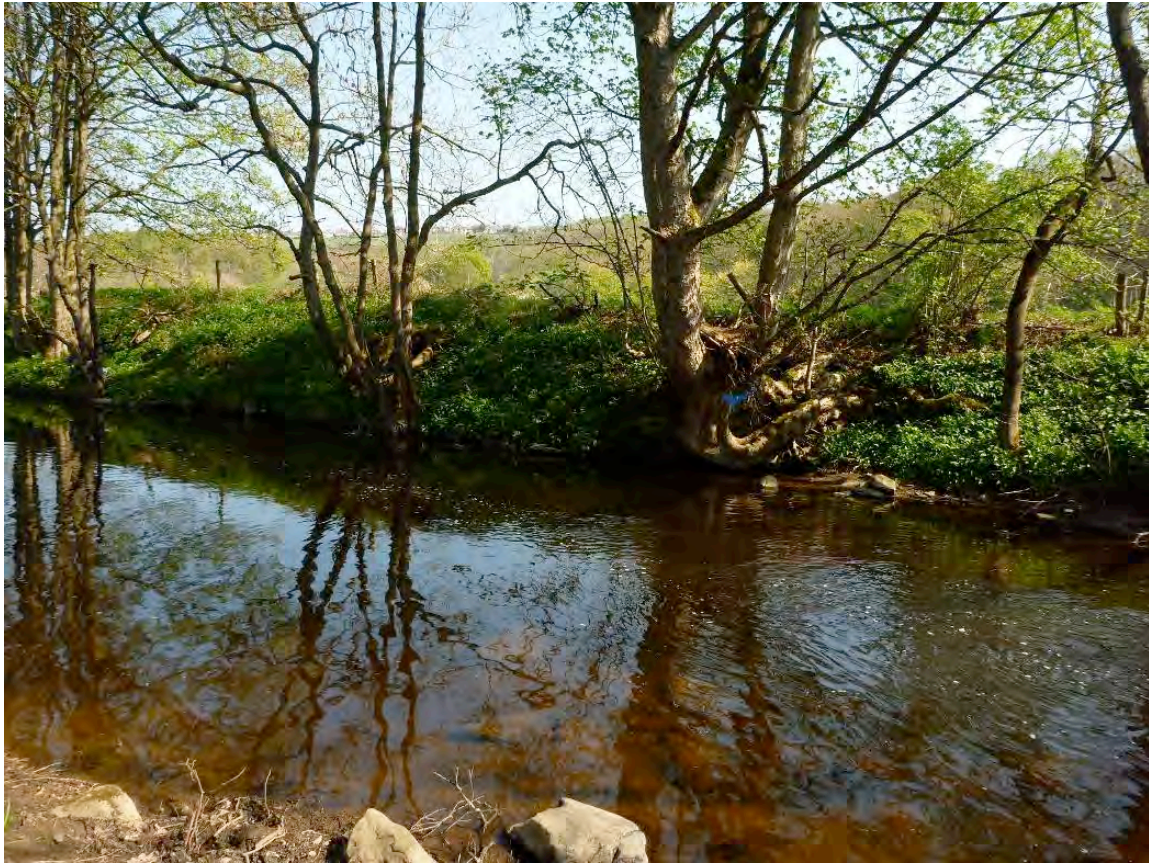
Figure 8: Pool that may benefit from tree kicker marginal cover

There is some potential to improve the available cover for trout along the RHB margin of this pool by tree kicker installation. This cover would augment the existing good depth adjacent to the main tongue of current feeding into the head of the pool to provide high quality lies for adult trout. Some of the denser brush cover would also be likely to be utilized by younger age classes of fish. The plan view for this proposal is given in Figure 15.

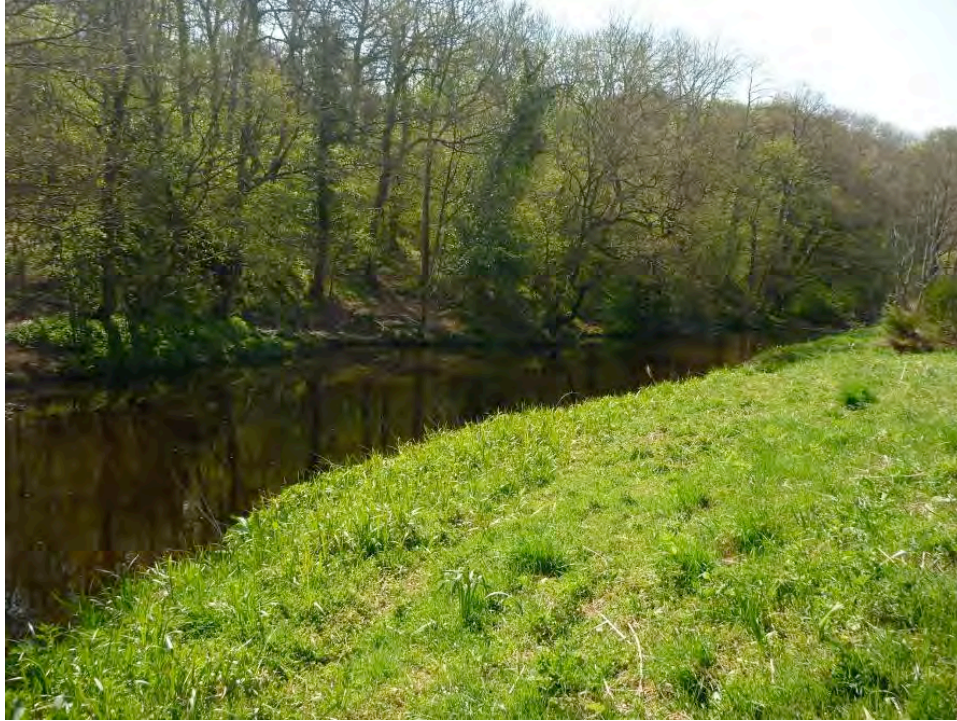
Once above the impounded section, a short riffle sequence is encountered along with some very good habitat. Further upstream again, there is a large slow pool lacking tree cover on the LHB (Fig.9) with fenced grazing exclusion in place. Planting out “whips” of goat or grey willow as well as other slower growing species (alder or oak) throughout this open area is recommended here. Trees planted directly adjacent to the watercourse can be hinged when large enough – or used for tree kickers (coppice regrowth will occur). A plan for the proposed scheme is given in Figure 16. It may also be possible for Derwent AA members to identify other suitable areas that may benefit from a little tree planting (e.g. NZ 10208 55850) and to obtain a better price for a bulk order of whips.

Figure 9: Long slow pool with treeless left hand bank (photo taken facing upstream)

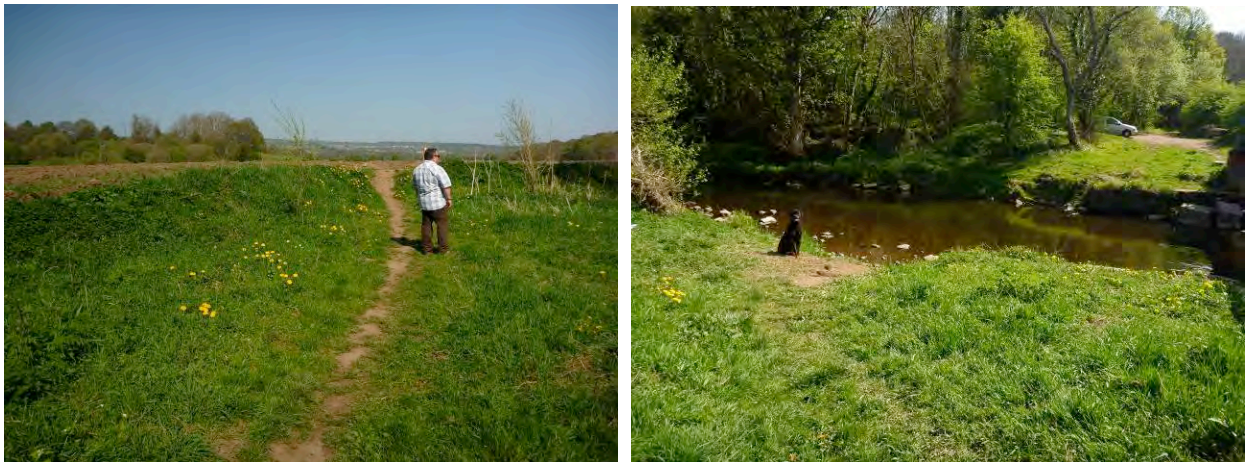
Figure 10: Impaction of footpath (left) is causing sediment inputs to the river (right) from adjacent ploughed field

Further downstream (below Ebchester), drainage during heavy rainfall from a ploughed field adjacent to the river is currently bypassing the generally well-vegetated riparian zone (Fig. 10). This is primarily a result of ground impaction due to footfall and is elevating the sediment load entering the river. As well as physical smothering of the stream bed, the sediment from agricultural land will tend to introduce additional nutrients as well as any pesticides or fungicides necessary for economically viable farming. Fine silt and filamentous algae (Fig. 11) are signs of the smothering/enriching effects of agricultural

runoff (exacerbated during low flow and warm weather). Proposed measures to mitigate sediment inputs are given in the next section (Fig. 17).

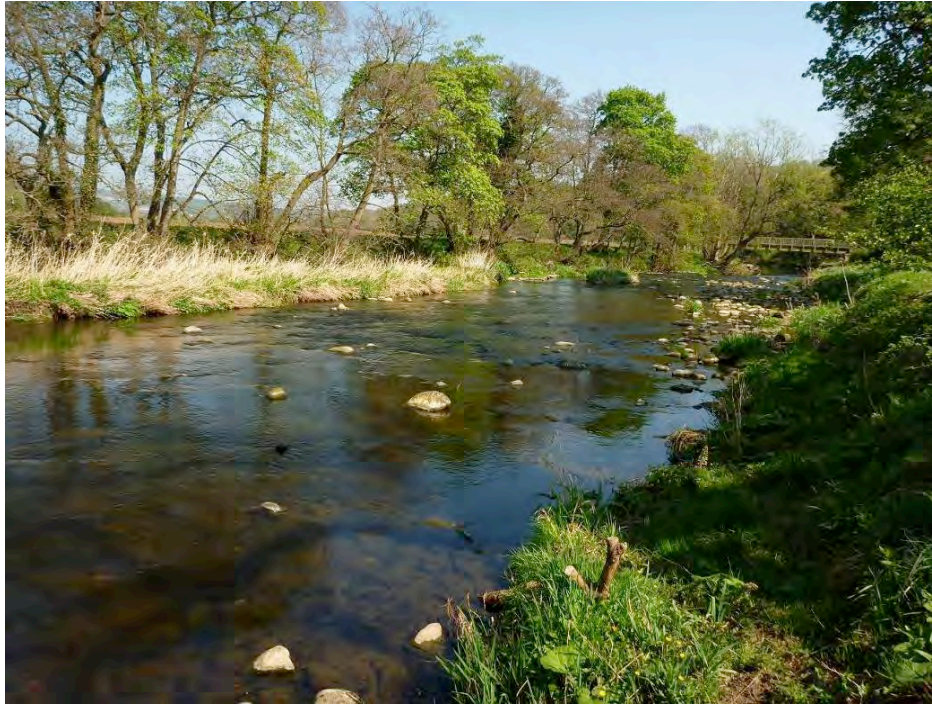
Figure 11: Signs of elevated sediment and nutrient inputs to the river – brown sludge and filamentous algae coating the riverbed. These signs are particularly evident under low flow conditions in warm weather. Elevated sediment and nutrient levels tend to degrade spawning areas and reduce invertebrate diversity

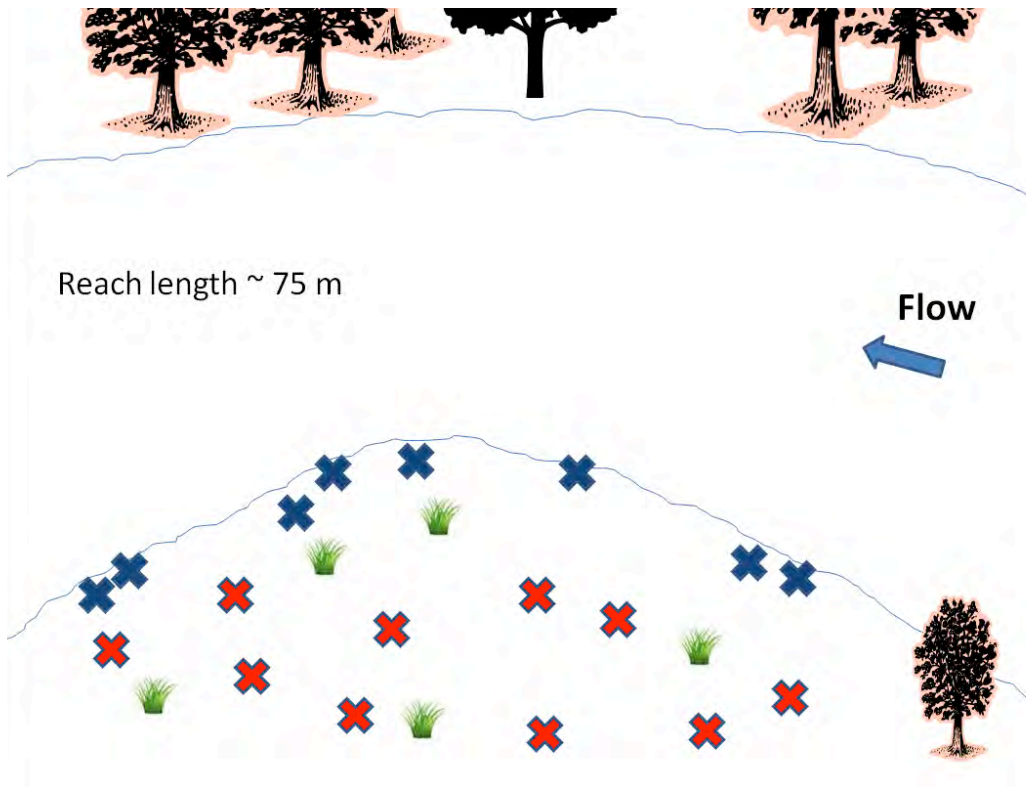
Figure 16: Tree planting at NZ 08455 50721. Blue crosses (adjacent to margin) to be a mixture of alder and goat willow. Red crosses suggested to be a mix of goat willow and oak. Additional advice could be sought from supplier/arboriculturist. Tree hinging and kickers on both banks should be phased in as vegetation establishes.
